OPERATING EXPERIENCE WEEKLY SUMMARY

Office of Nuclear and Facility Safety

September 18 - September 24, 1998

Summary 98-38

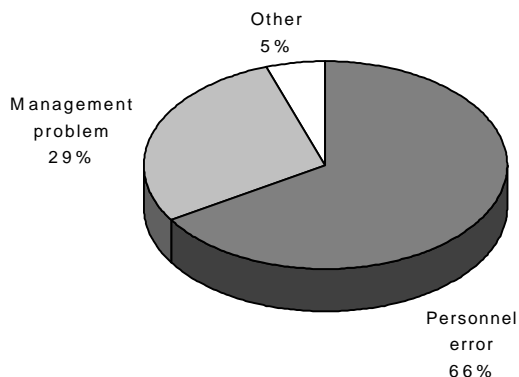
OEAF engineers searched the ORPS database for occurrences involving radiation work permit violations and identified 56 occurrences. A review of these occurrences shows that managers reported the root cause for 66 percent of these occurrences as personnel error and reported 29 percent as management problems. Figure 2-1 shows the distribution of root causes for these events. Further review of the personnel error shows that managers reported 36 percent as procedure not used or used incorrectly, 23 percent as inattention to detail, and 7 percent as other.

Figure 2-1. Distribution of Root Causes for Radiation Work Permit Violations¹

These events illustrate the need for workers to be accountable and consider the consequences of performing work outside the scope of procedures, radiation work permits, and work packages. In this event, a worker was contaminated and spread contamination by performing maintenance without using the radiation work permit. The purpose of the permit is to clearly inform workers of conditions and entry requirements. When workers violate the requirements, they increase the probability of the spread of contamination and exposure to radiation. Workers must guard against complacency when performing routine work. Workers must also read and understand permits before signing them. Before signing a radiation work permit, personnel should be aware of (1) radiological conditions, (2) dosimetry requirements, (3) training requirements, (4) protective clothing and respiratory protection requirements, (5) stay times, and (6) conditions that may void the radiation work permit.
